NDI No. PA 00908
PENN DER No. 63-78

REFUSE SETTLING BASIN

UNITED STATES STEEL CORPORATION
RAW MATERIALS DIVISION

PHASE I INSPECTION REPORT
NATIONAL DAM INSPECTION PROGRAM

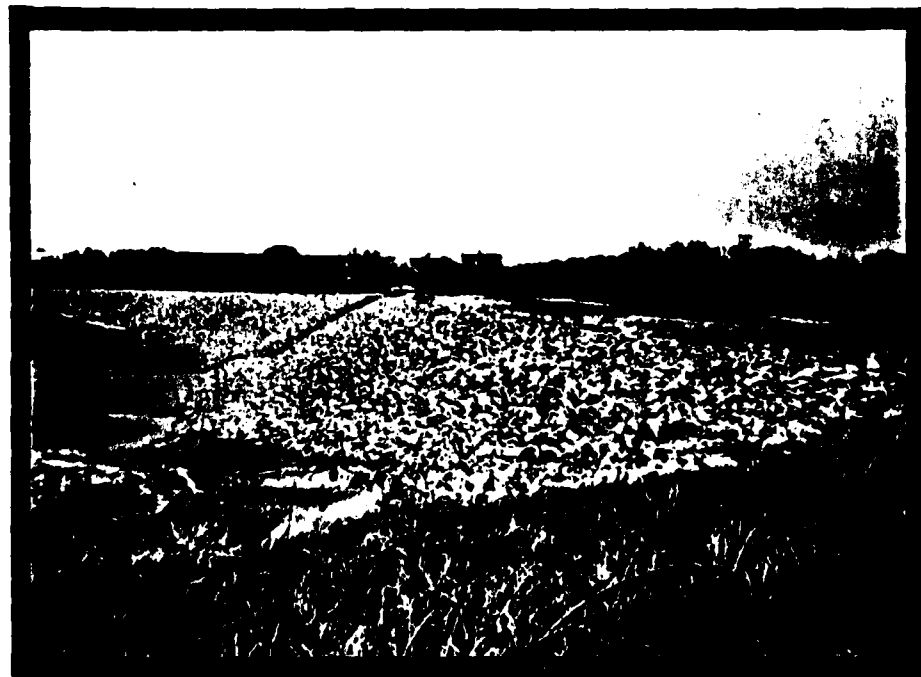
Photo 2 Embankment A - Upstream Slope. Dark strip at center of embankment is slurry discharge stream.

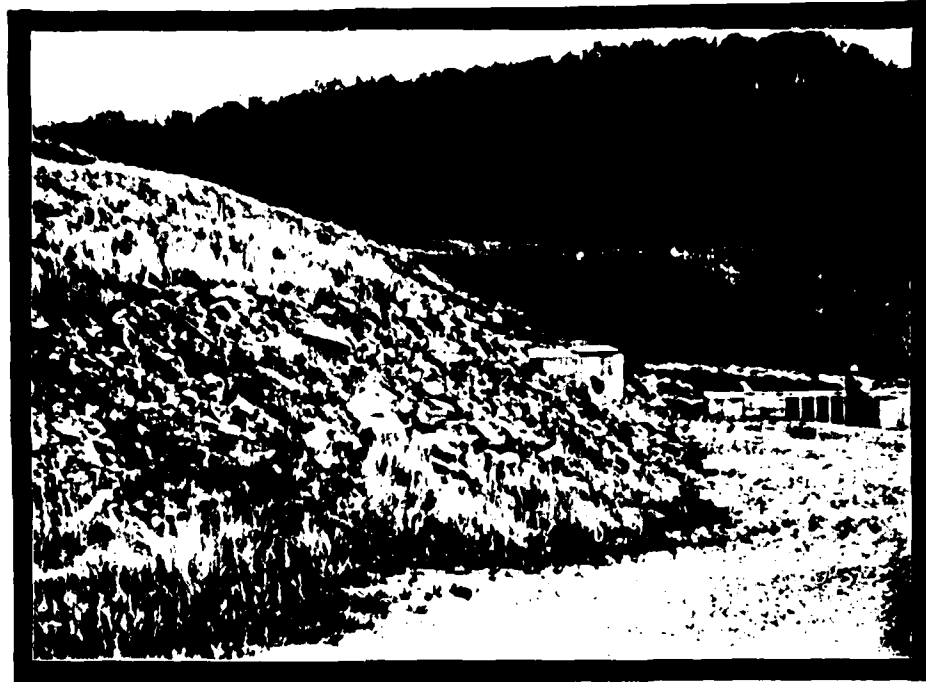
On the left, the abutment drops into a valley which is generally swampy and contains considerable water related vegetation. Also, some softness in the toe area was observed immediately below the slump of the rockfill toe area described earlier.

The swampy areas were generally soft and contained standing water, but no moving water was observed.

Photo 3 Embankment A - Downstream Toe Area showing principal spillway outlet structure. Note swampy conditions beyond embankment toe.

- a. Review and evaluation of monitoring instrument data.
- b. Investigation of the swampy conditions at and below the toe of the embankment.
- c. Stability calculations, if necessary.

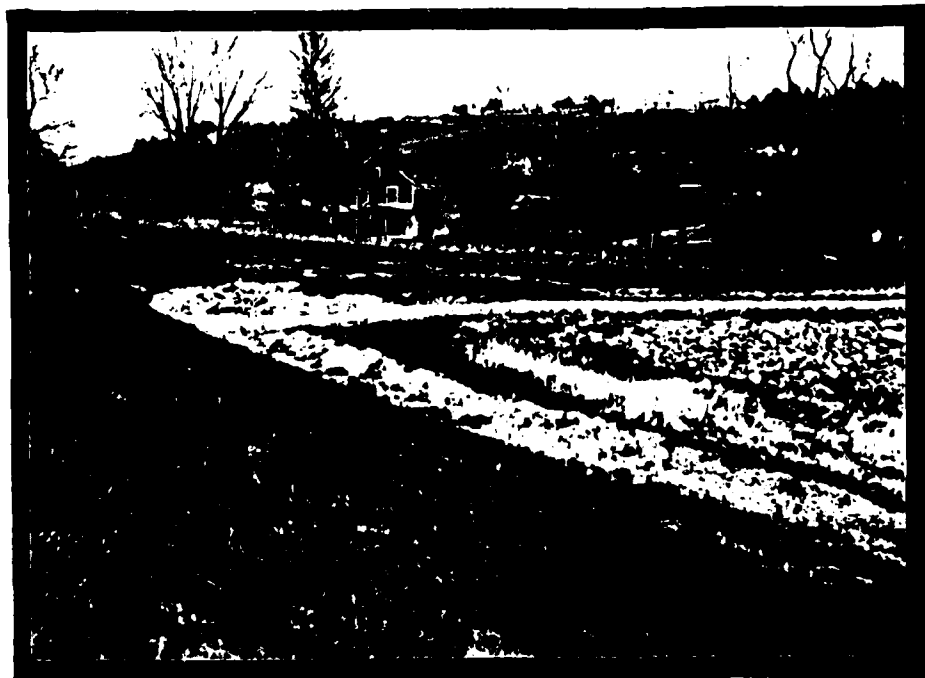
Photo 4 Emergency Spillway Channel on left abutment of Embankment A.

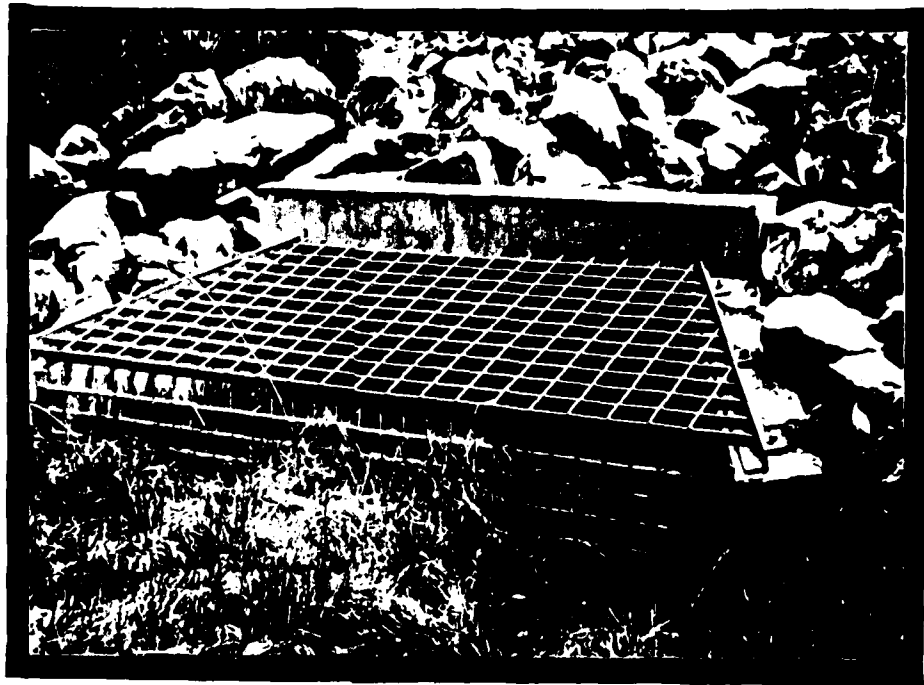
Photo 7 Underflow Pipes Inlet at downstream
(up-valley) toe of Embankment B.

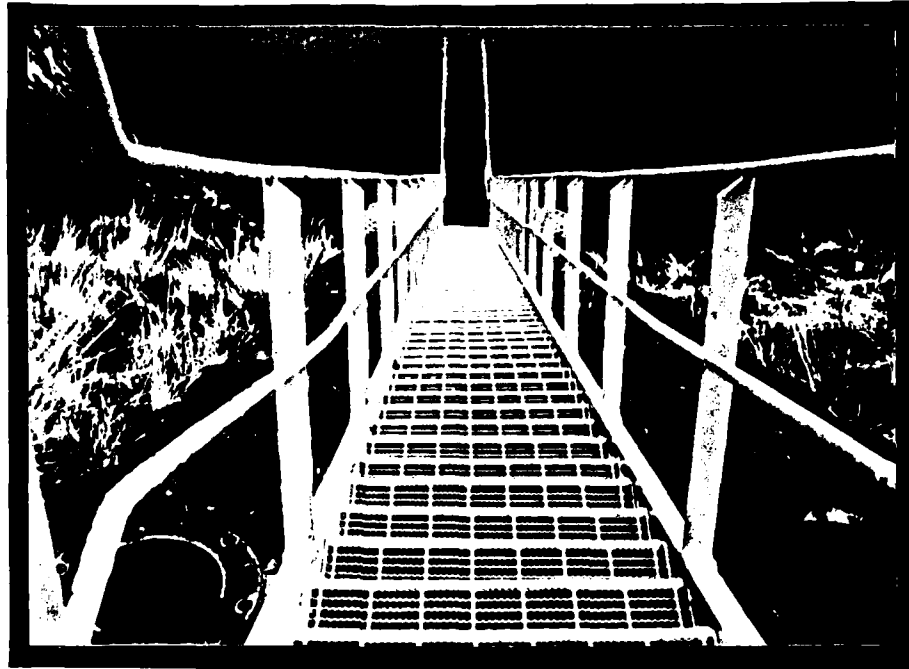
Photo 9 Principal Spillway Intake Ports and access stairway.

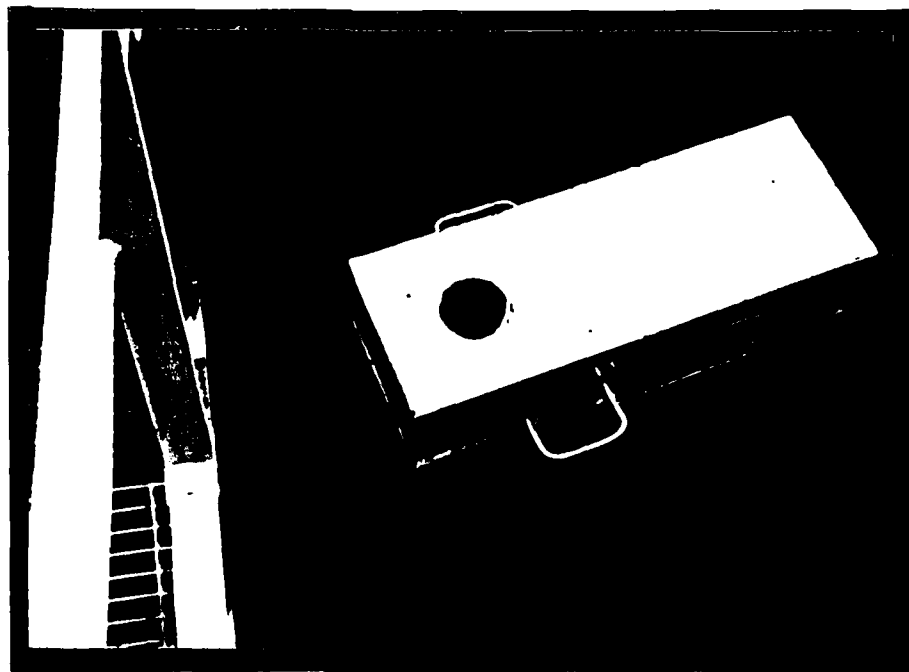
Photo 10 Principal Spillway Intake Port with flow control box.

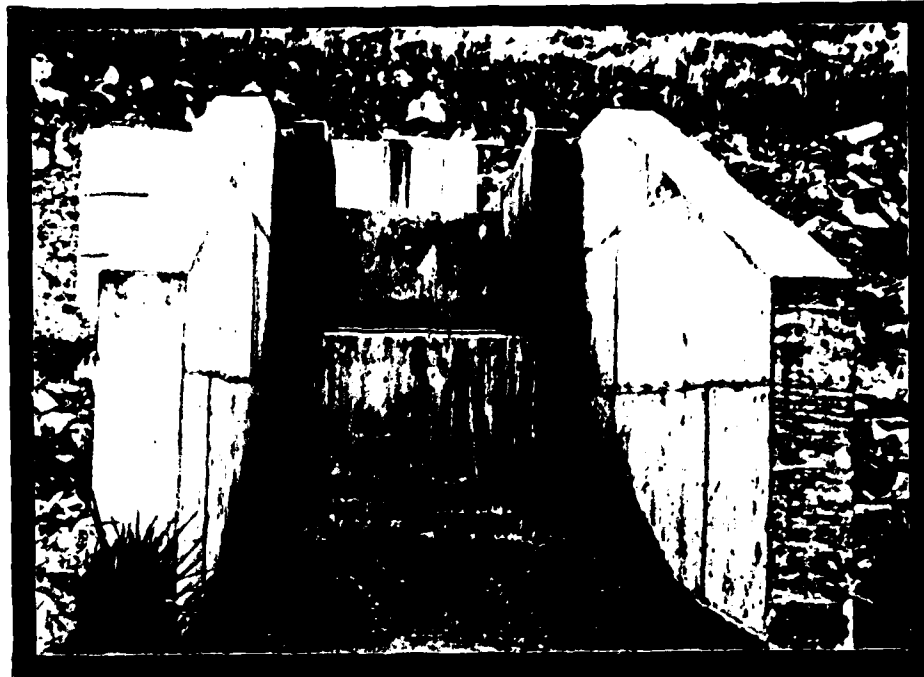
Photo 11 Principal Spillway Outlet Structure showing overflow weir from below.

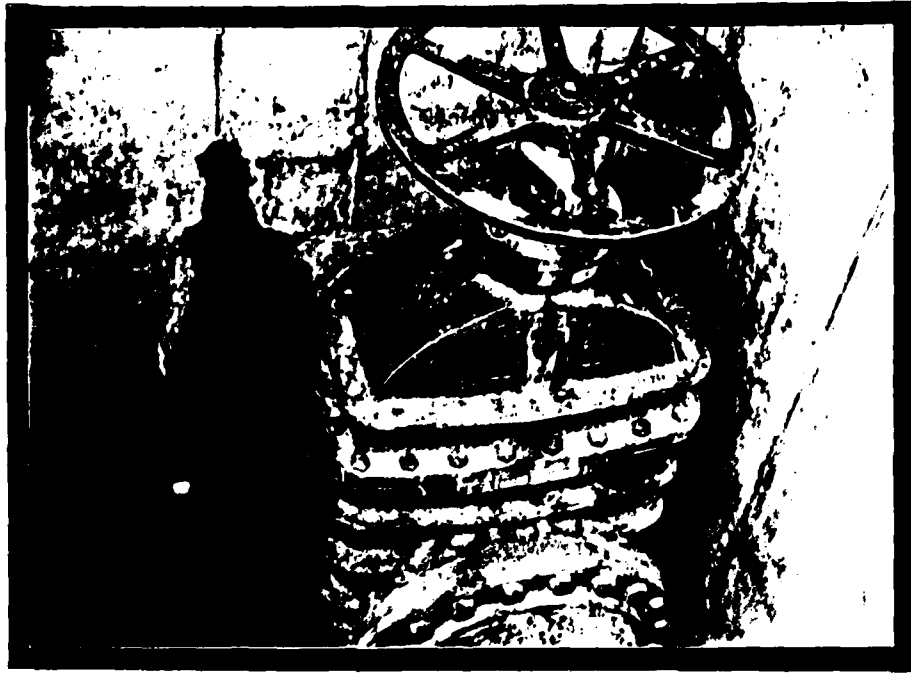
Photo 13 Principal Spillway Outlet Structure showing gate valve control which is immediately upstream of the overflow weir shown on Photo 11.
